Grandview Bridge

OWNER: Idaho DOT

YEAR: 2016

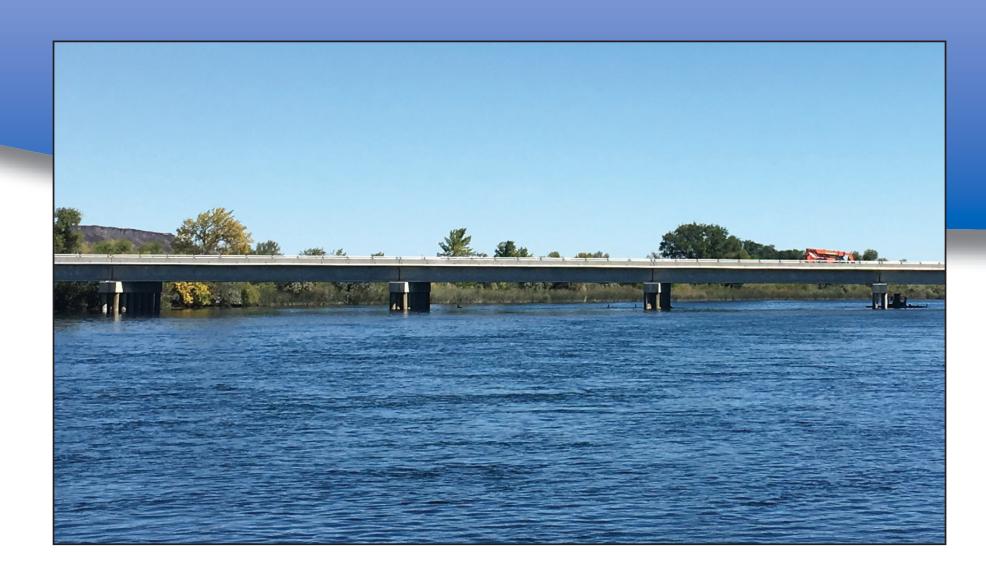
Badly Damaged Piles Prior to Repair

The Challenge — The bridge spanning the Snake River in Grandview, Idaho was in dire need of repairs. Many of the piles had deteriorated due to the harsh marine environment. The Idaho DOT sought a way to extend the life of the structure without the high cost of replacing it.

The Solution — Five Star Products, Inc. was approached and able to offer the complete solution. The first step was to repair and reshape extensive voids in the piles with Structural Concrete[®] Underwater Hand Pack. This hand-applied product is specifically engineered for underwater use and sets rapidly with minimal washout. Once that was complete, 25" diameter PileForm™ F fiberglass reinforced plastic pile rehabilitation encasements were used to surround each of the damaged piles. The 1/2" annulus was then filled with long pot life underwater Pile Jacket Epoxy Grout LPL to form a permanent repair.
